**Death in the line of duty...****NIOSH**
Fire Fighter Fatality Investigation
and Prevention Program

July 6, 2011

Two Career Fire Fighters Die and 19 Injured in Roof Collapse during Rubbish Fire at an Abandoned Commercial Structure – Illinois

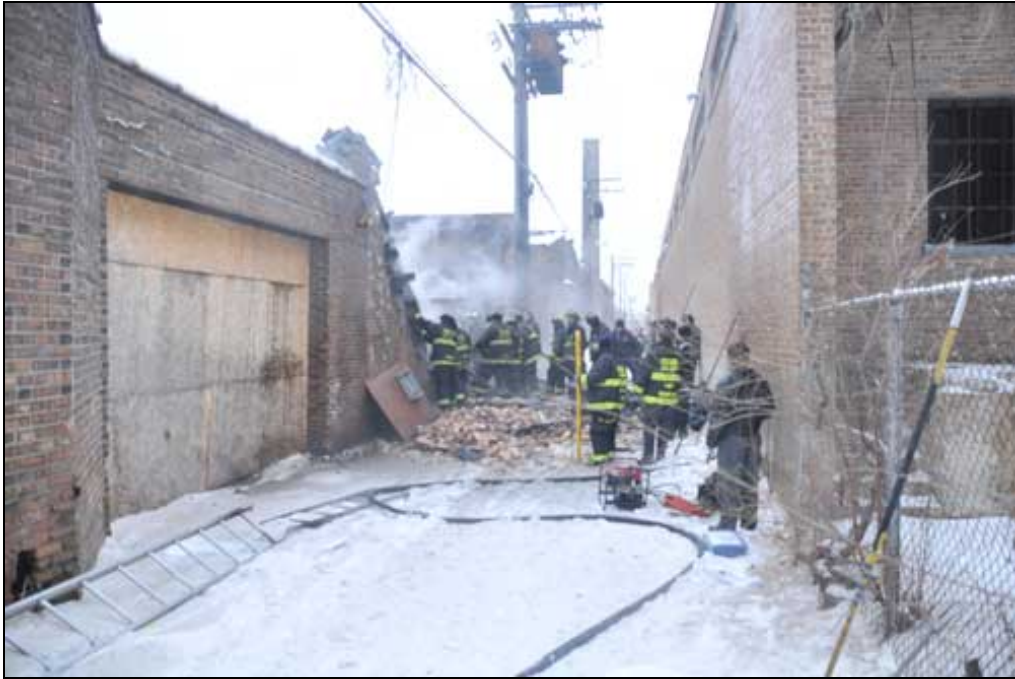
Photo 1. 12-foot wide public alley directly behind structure (Sector 3).
(Photo courtesy of fire department)

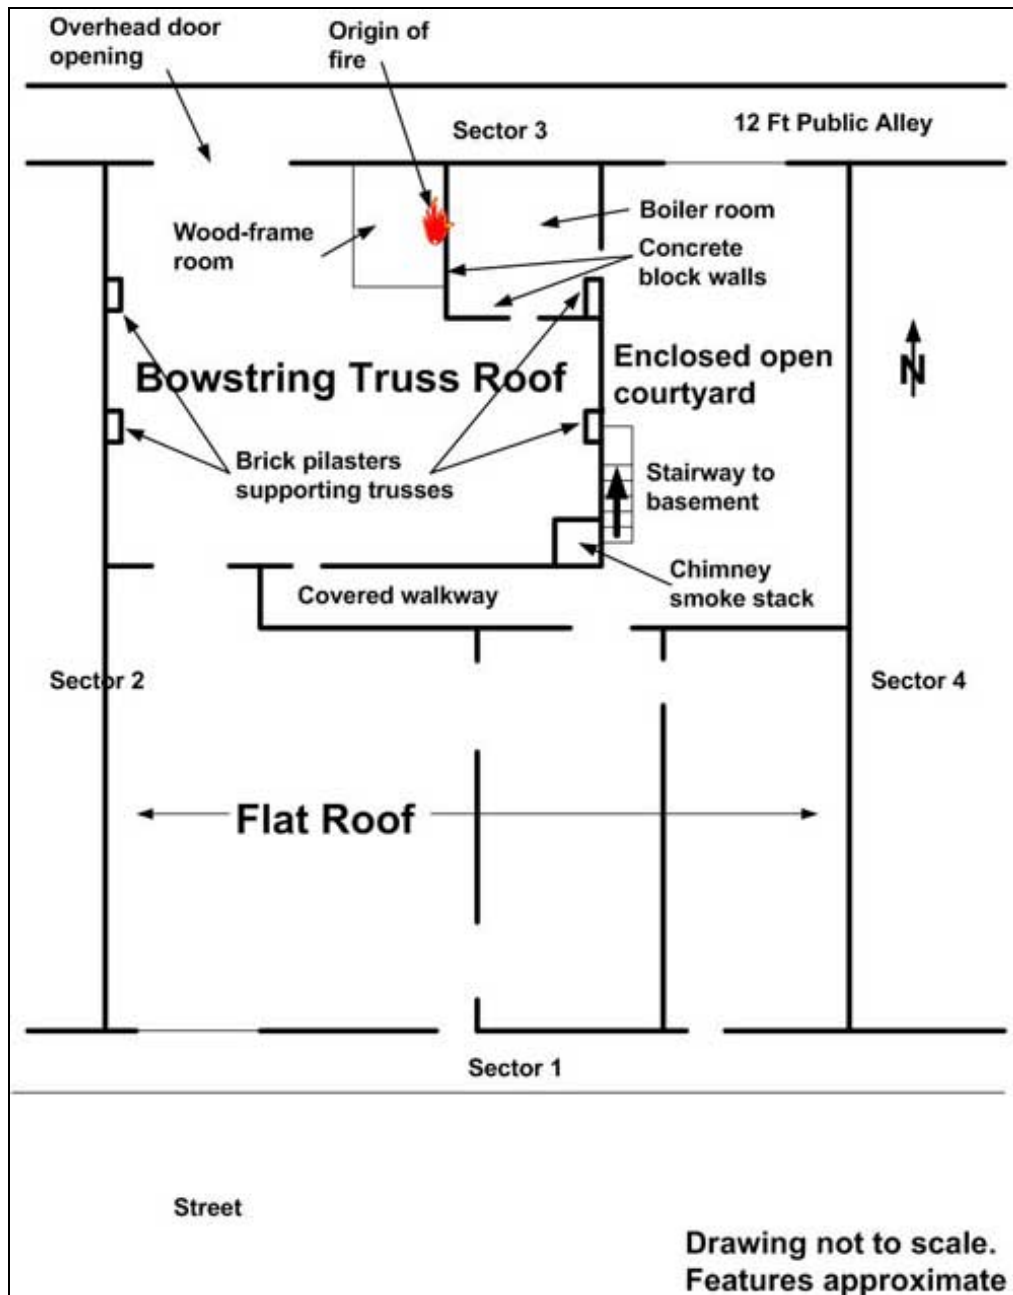
Diagram 1. Approximate layout of the fire building.

The structure involved in this incident was a one-story commercial structure of Type III ordinary construction originally built in 1926. City records listed the structure at 6,700 square feet. The structure was constructed with brick masonry walls and separated into two sections – front and back. The front section had a flat roof and the back section had a bowstring truss roof ([see Diagram 1](#)). The two separate roof types suggest the back section (with bowstring truss roof) may have been added after the original construction. Parapet walls at the front and rear obscured the roof from street level. The front of the structure was adjacent to a major east-west street. The west wall and the front portion of the east wall were common to adjoining businesses. The building to the west was still in use at the time of the incident. An enclosed open courtyard was located to the east of the back section of the structure. The structure showed evidence of prior substantial renovation work with exterior doors and window openings bricked up, especially at the rear and courtyard areas. A 12-foot wide public alley was located directly behind the rear of the structure (see [Photo 1](#) and [Diagram 1](#)).

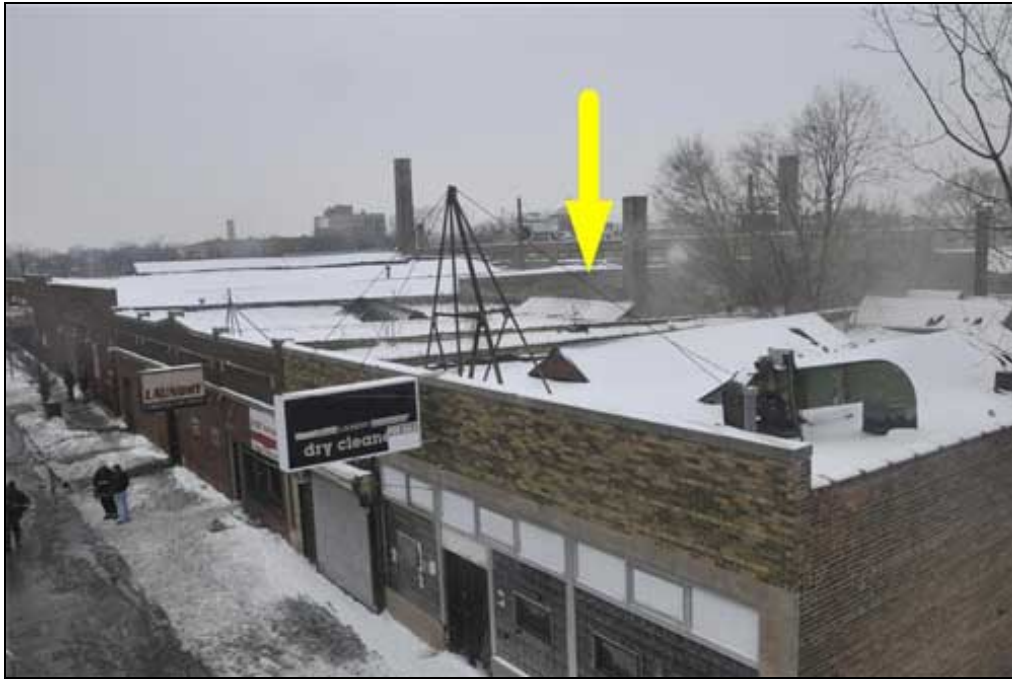
The structure was located in an area that contained both vacant and abandoned buildings ([see Photo 4](#)). The structure had been abandoned^b by the owner for more than 5 years, and was formerly the site of a commercial laundry. The structure had never included a sprinkler system. It was reported that natural gas service to the building had been shut off since 2005 and electrical service had been shut off since 2009.

Photo 4. Elevated view of the block where the incident occurred, taken the day of the fire. The arrow marks the location of the collapse. The photo has been edited to remove names and identifying information from signs.

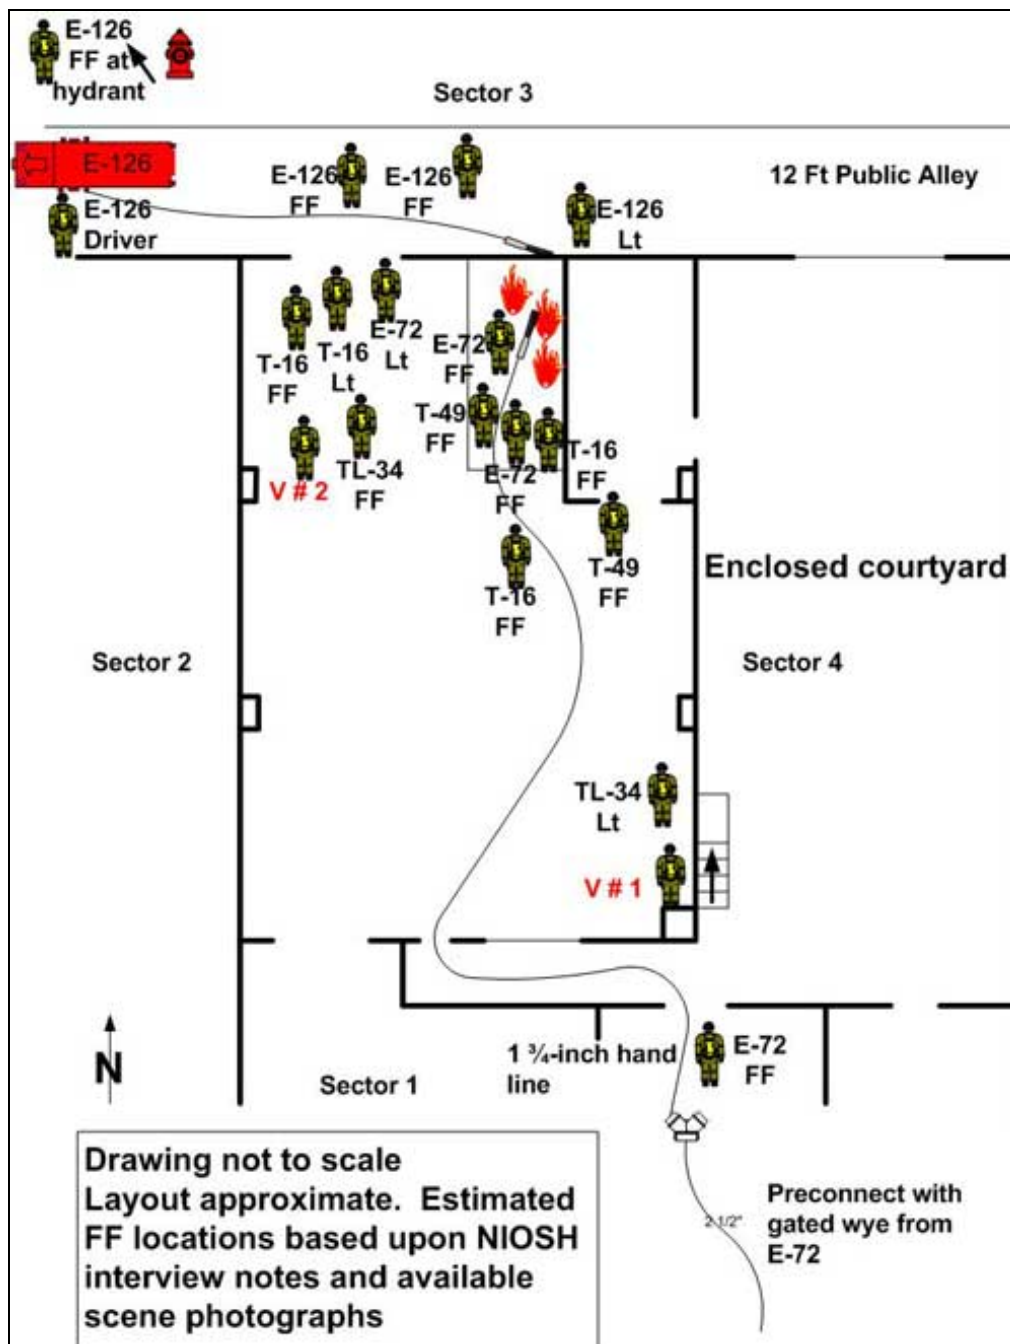
Diagram 3. Approximate location of the fire fighters inside structure and in alley at time of the roof collapse. Five fire fighters were also on the roof at the time of the collapse.

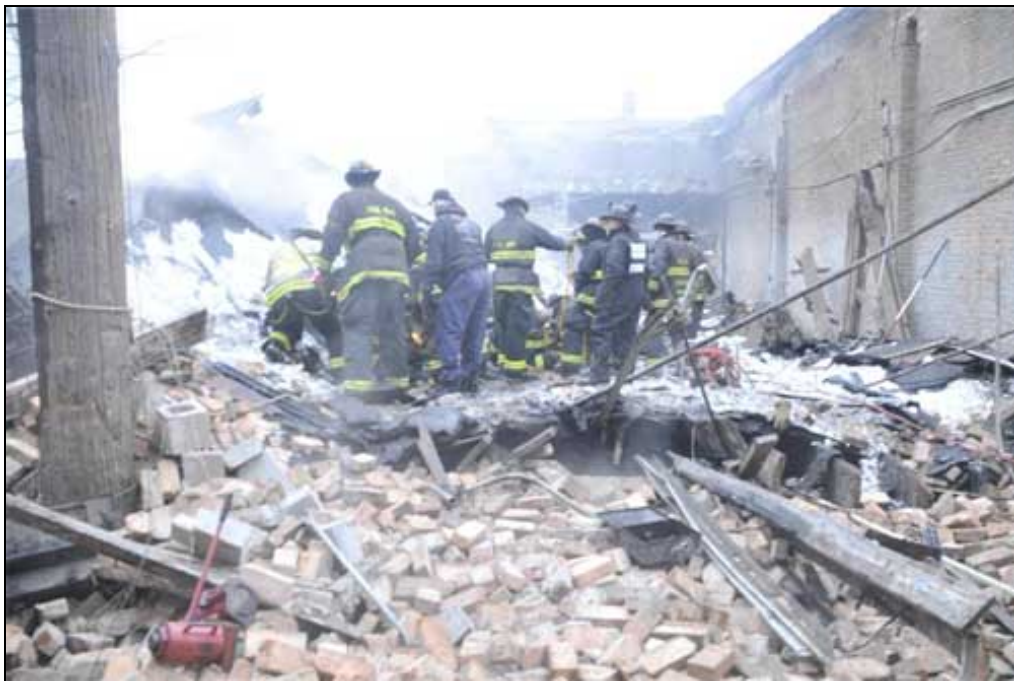
Five fire fighters were working in close proximity to the area enclosed by the wooden wall studs west of the concrete block room. The E-72 fire fighter working the nozzle was closest to the Sector 3 wall. The collapsing roof pushed the E72 fire fighter down to a crouching position (during the interview with NIOSH investigators, he referred to the position as a baseball catcher's position). His head and shoulders were pinned by the collapsed roof so that he could not move and his facepiece was dislodged. He began to yell out for help and the Truck 30 crew along with the E-126 lieutenant and other fire fighters began to dig the bricks and roof material from around his head ([see Photo 11](#)).

Photo 11. Crews work to free fire fighters from Engine 72, Truck 49 and Truck 16 trapped under collapse.
(Photo courtesy of fire department)
